O&M REPORT  
FOR Kahului Bay Mitigation  
Honolulu Engineer District  
CEPOH-EC-T

1. Project Name: Kahului Bay SPP

2. Date of Inspection: August 14, 2007

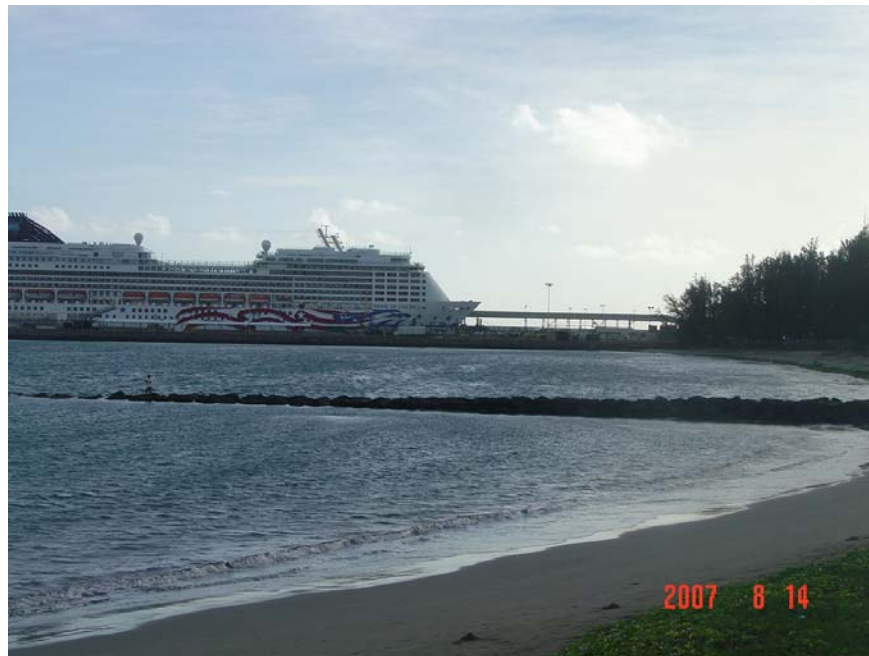
a. Sta. 0+10, Left Side (LS), Tree has been removed.

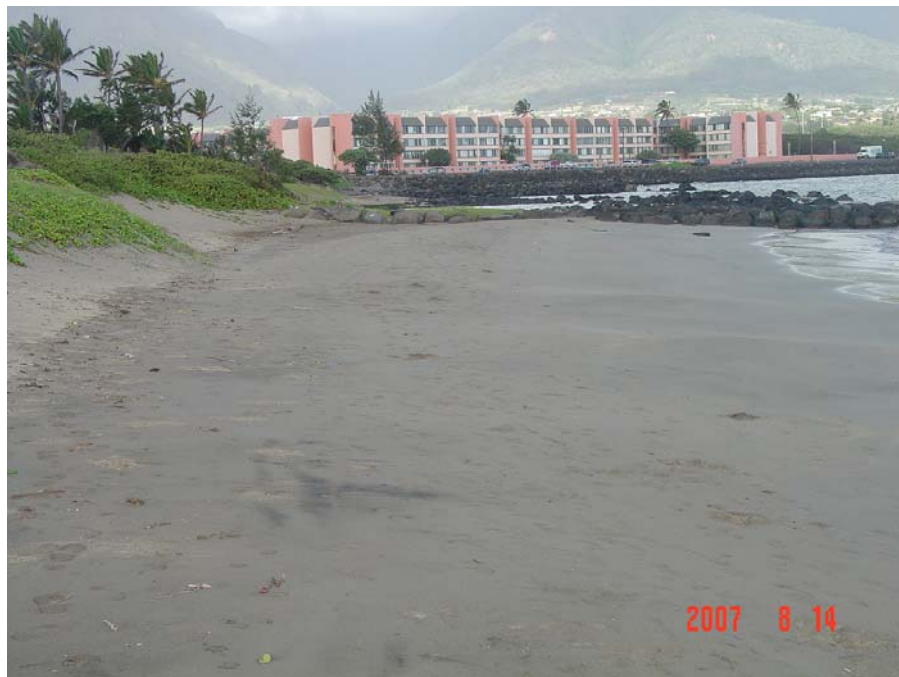
- a. Overview of beach fill. It appears that a large portion

of the beach has eroded.  
West Groin 280':

The East Groin is in good condition. The West Groin is in need of minor repairs. It appears the breakwater is in extremely poor condition and a survey needs to be conducted to determine the sand nourishment present condition. Sand nourishment and breakwater repairs should be accomplished as outlined in the Detailed Project Report, Section G, Page 41. The revetment is showing further signs armor stone displacement / movement at Sta. 0+51.

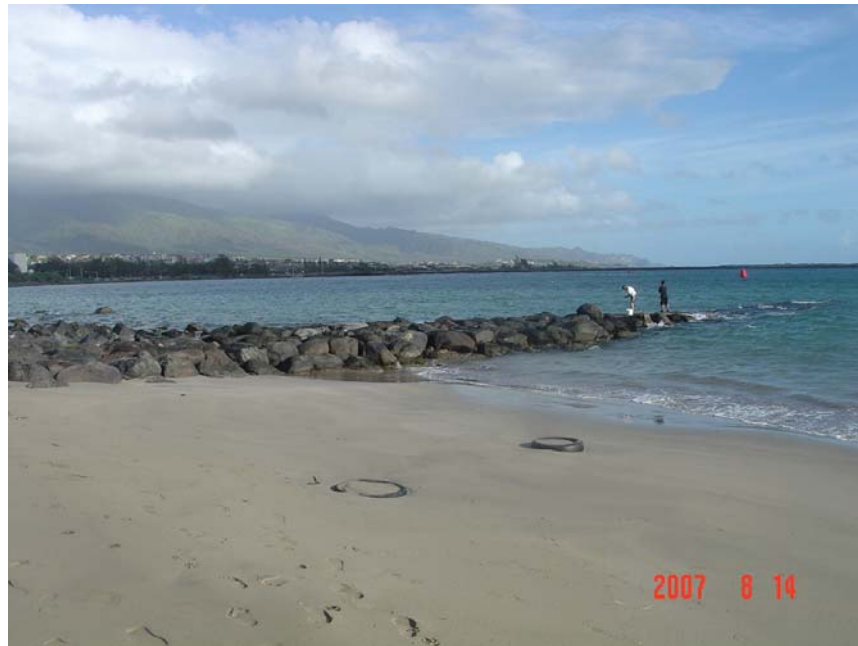
a. Sta. 1+48, No changes this year.

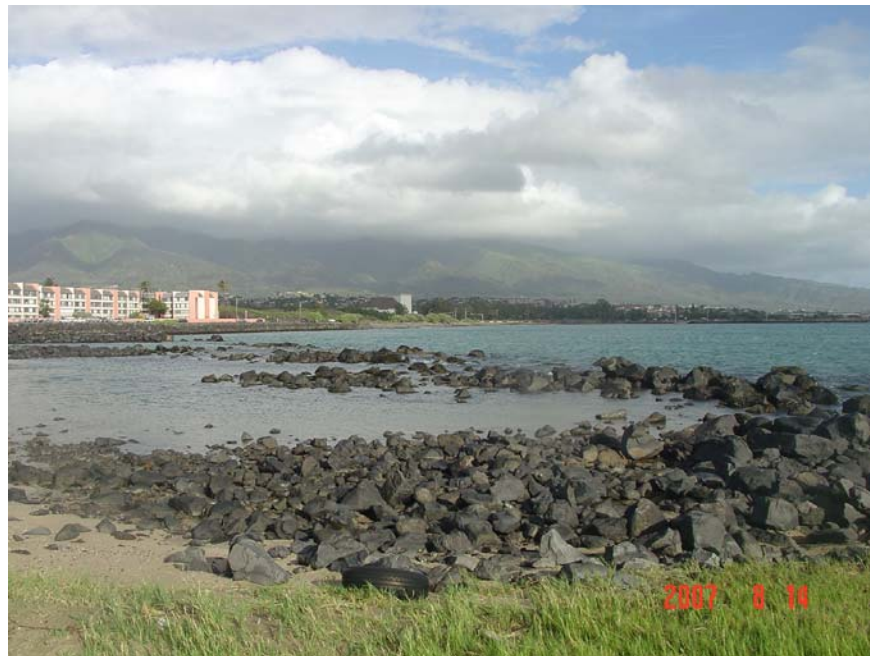
a. Breakwater Overview, a survey needs to be conducted to determine the scope of repairs required. Designed to elevation +2' and connected to the scatter field.

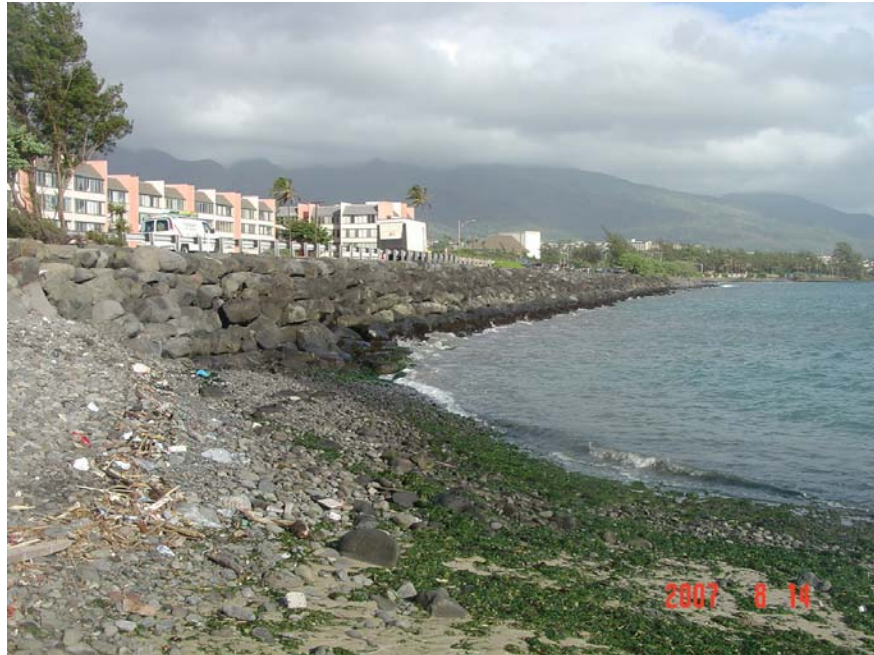
a. Sta. 0+00, Overview of revetment, no changes this year.

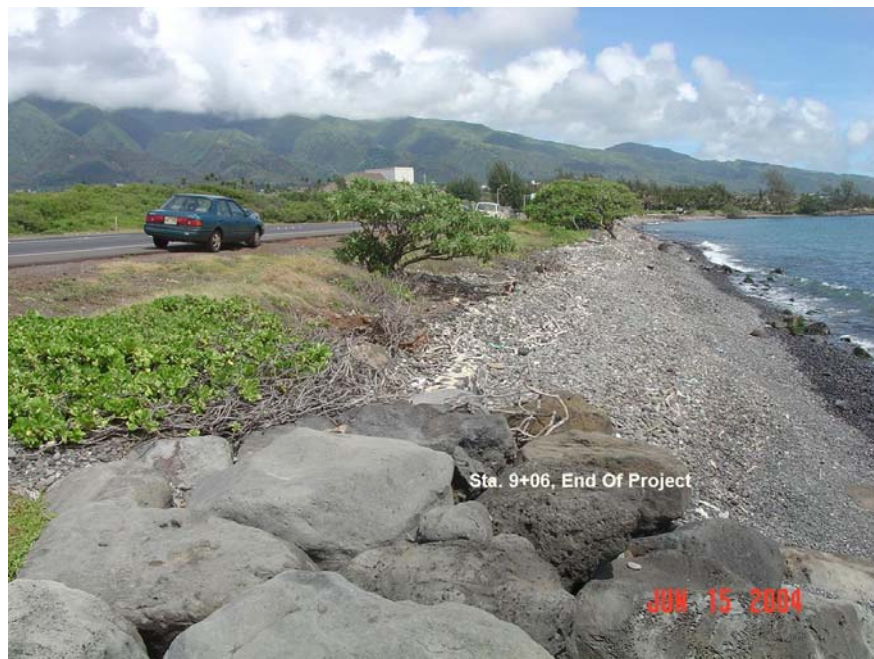
b. Sta. 9+06, End of Project.

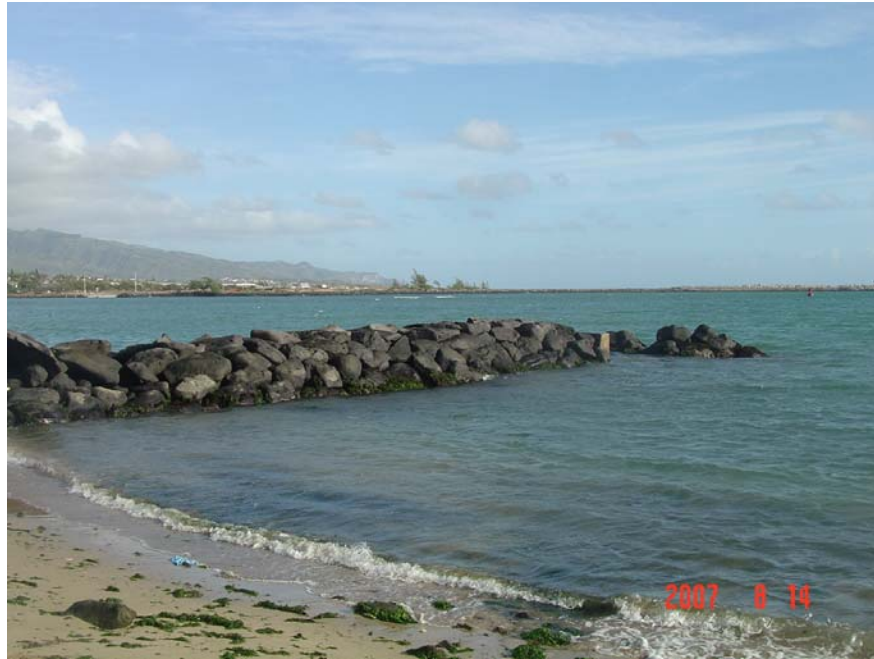
Non-Related structure within project limits.
